DEPARTMENT OF TRANSPORTATION

Quality Assurance and Source Inspection

Contract #: 04-0120F4Cty: SF/ALA Rte: 80 PM: 13.2/13.9File #: 1.28**WELDING INSPECTION REPORT****Resident Engineer:** Casey, William**Address:** 333 Burma Road**City:** Oakland, CA 94607**Report No:** WIR-029815**Date Inspected:** 16-Jul-2013**Project Name:** SAS Superstructure**OSM Arrival Time:** 700**Prime Contractor:** American Bridge/Fluor Enterprises, a JV**OSM Departure Time:** 1730**Contractor:** American Bridge/Fluor Enterprises, a JV**Location:** Job Site**CWI Name:** Jesus Cayabyab**CWI Present:** Yes No**Inspected CWI report:** Yes No N/A**Rod Oven in Use:** Yes No N/A**Electrode to specification:** Yes No N/A**Weld Procedures Followed:** Yes No N/A**Qualified Welders:** Yes No N/A**Verified Joint Fit-up:** Yes No N/A**Approved Drawings:** Yes No N/A**Approved WPS:** Yes No N/A**Delayed / Cancelled:** Yes No N/A**Bridge No:** 34-0006**Component:** SAS Tower**Summary of Items Observed:**

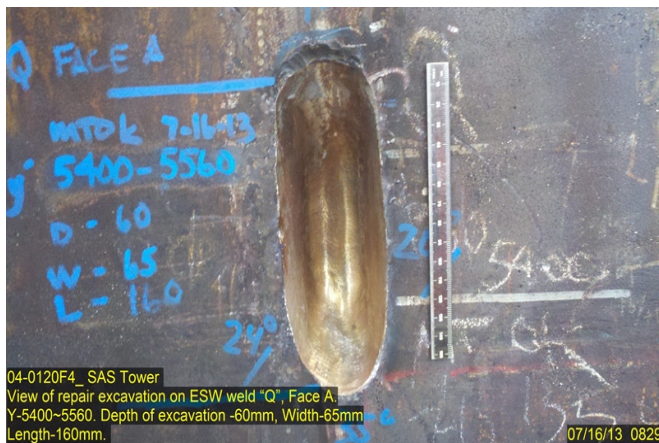
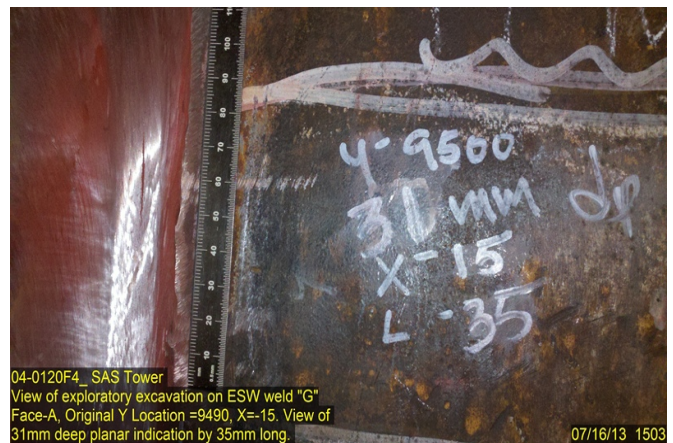
ESW S-045,"G"-Face A:

The QA Inspector was present to observe ABF welder Kit Lai (WID-2953) performing exploratory excavation of

ESW "G" Face A @ Y-9490mm to verify indications observed during Ultrasonic Testing pulse/echo & pitch/catch.

QC Inspector Jesse Cayayab stated that Mr. Lai will excavate every 5mm deep and allow QC/QA to inspect the excavation. After grinding to bright metal the QC Inspector performed MT testing of the excavation to inspect for planar indications at each hold point. The QA Inspector also performed MT inspection throughout the process and the final excavation. Location of the planar indication observed in the excavation was:

ESW "G", Face A

Indication first discovered at Y= (Original) 9490mm, actual Y-9500, X= -15

Indication removed at: 38 mm deep

Final excavation Y=9400mm~9620mm, Length=220mm, Width=50mm & Depth=38mm.

ABF QC Representative Chris Chew stated that ABF do not have approval to weld the ESW PC excavation locations at this time and will only be excavating to verify the indications and remove them. The QA/QC Inspectors did verify that the planar type indication was removed on this shift. See TL-6028 for additional details on items inspected.
